# Manhole Inspection Summary

Manhole # S31M1\_014MH

Insp Date: **2/6/08 12:43 PM**

**Location** Address: **401 Roundview Road**

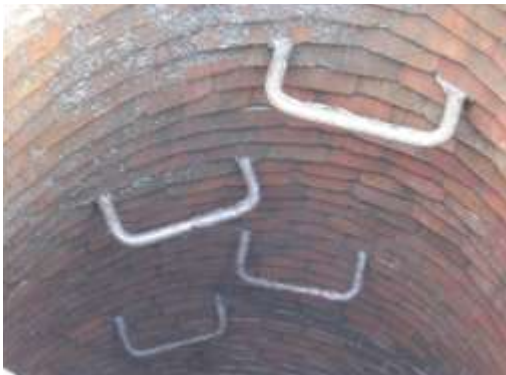
Steps

Count: **4** Missing: **0** ☐ Corroded

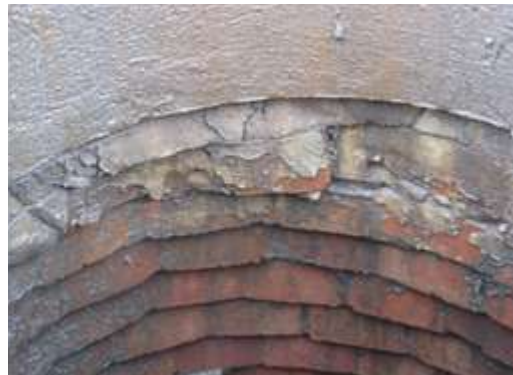
Defect 2

Condition: ☐ Sound ☐ Cracked ☐ Root Intrusion ☒ **Loose Brick** ☐ Deteriorated

Infiltration: ☐ None ☐ Joint ☐ Cracks ☒ **Mortar** ☐ Roots ☐ Wall

Infiltration

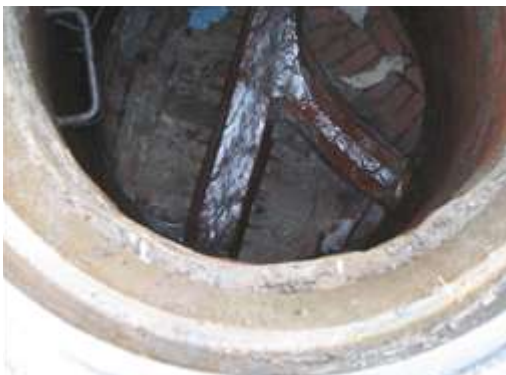
Defect 1

Offset: **1.5** (in.)

Frame offset

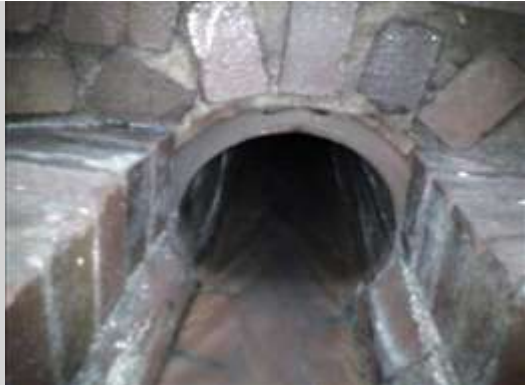
12 O'Clock Outflow

Pipe Height: **10.8** (in.) Rod and Bar (Angled)  
Pipe Material: **Clay** ☐ Pipe Lined  
Invert Depth: **9.46** (ft.) Flow Characteristics: **Fast**  
Deposits: ☒ None ☐ Mud ☐ Sludge ☐ Debris ☐ Grease  
Silt Depth: (in.) Deposits Extent:  
Infiltration: **None** Pipe Seal Cond: **Sound**

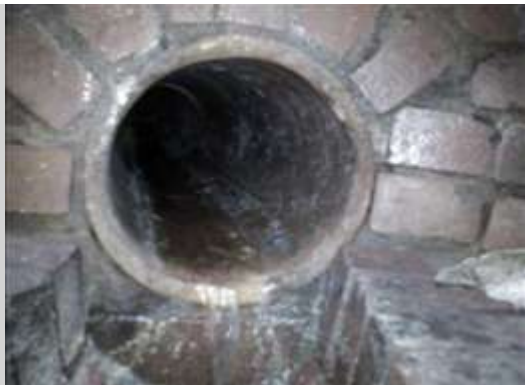
4 O'Clock Inflow

Pipe Height: **9.6** (in.) Rod and Bar (Angled)  
Pipe Material: **Clay** ☐ Pipe Lined  
Invert Depth: **8.56** (ft.) Flow Characteristics: **Fast**  
Deposits: ☒ None ☐ Mud ☐ Sludge ☐ Debris ☐ Grease  
Silt Depth: (in.) Deposits Extent:  
Infiltration: **None** Pipe Seal Cond: **Sound**

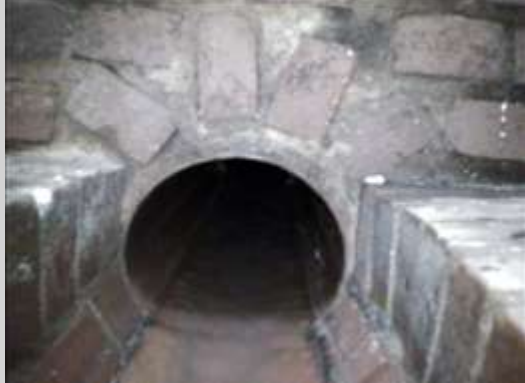
6 O'Clock Inflow

Infiltration: **None** Pipe Seal Cond: **Sound**
